# Fine Tuning

# Variable Valves - Plus More

Our third case study involves a 2001 Nissan Sentra GXE, also with the 1.8L QG18DE engine found in the first two case studies. The vehicle failed an Illinois OBD II inspection for a P0335 crank sensor diagnostic trouble code (DTC). If the DTC is cleared, it resets very quickly and matures to a stored DTC. The code definition suggests that a DTC P0335 may be caused by a POS/PHASE sensor synch issue. The engine also surged at idle. Figure 1 on page 3 illustrates the idle surge in PARK and DRIVE.

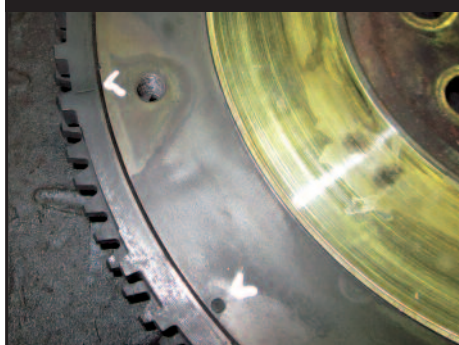
The painted arrows in this photo highlight assembly marks on the flywheel and exciter ring gear. These marks should be aligned.

As you can see clearly in the photo above, the exciter ring gear had moved. The ring gear is an interference shrink fit to the flywheel, with

what appear to be punch marks for insurance. There are no actual spot welds to hold it in place. After replacing the flywheel (the dealer had two in stock), the engine ran great again.

The question is what could have made the exciter ring slip? After looking a little closer, it appeared there was some heat discoloration where the clutch disc contacted the flywheel. I talked with Bob and he said the clutch had been replaced twice in this vehicle. Keep in mind that it has only 65,000 miles on it. Does this indicate a problem with the pressure plate, clutch disc or the driver's habit of riding the clutch? It is unknown at this time, but it does appear excessive heat had something to do with the exciter ring movement.

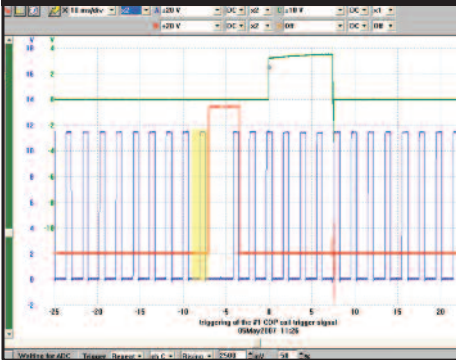
**Figure 2:** This is a known-bad pattern. The exhaust cam appears to be retarded about 10 crank degrees.

When energized, the variable valve timing system should advance the intake cam timing by 20 crankshaft degrees. However, the exhaust cam sensor waveform appears to be retarded by about 10 crank degrees. The timing chain is probably stretched, which also caused the P0355. Although the variable valve timing mechanism causes the intake camshaft to advance as it should, the intake camshaft timing also is about 20 crankshaft degrees retarded. This is probably responsible for the surge. The intake cam sprocket may have jumped a tooth, or there may be another mechanical explanation.
